Manhole Inspection Summary

Manhole # S09WW_008MH

Insp Date: **2/23/08 1:33 PM**

Location Address: **3501 LIBERTY HEIGHTS AVE** Cross Street: **EDGEWOOD ST**

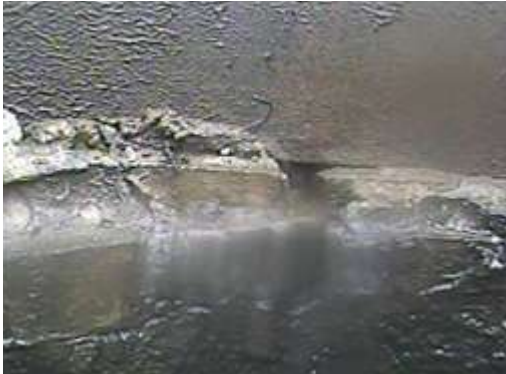
Defect 1

Chimney / Frame Adjustment ☒ Exists Material: **Brick** ☐ Parged Height: **3** (in.)
Condition: ☐ Sound ☒ **Cracked** ☐ Root Intrusion ☐ Loose Brick ☐ Deteriorated
Infiltration: ☐ None ☐ Joint ☒ **Cracks** ☐ Mortar ☐ Roots ☐ Wall

LOTS OF INFILTRATION AT THE
FRAME ADJUSTMENT THROUGH
CRACKS.

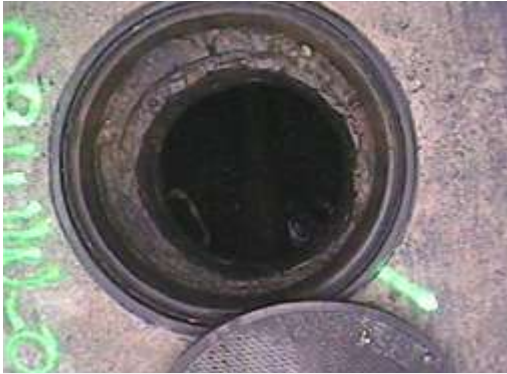
Defect 2

Frame Offset: **6** (in.) Condition: ☒ Sound ☐ Cracked ☐ Leaks

OFFSET FRAME

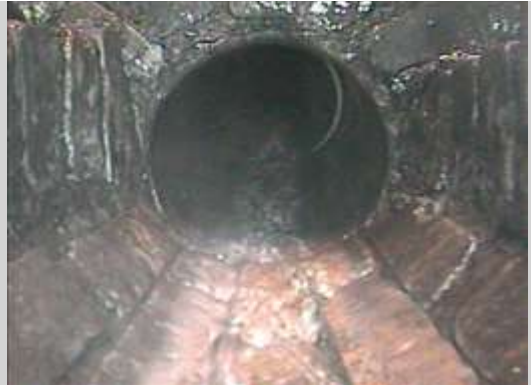
12 O'Clock Outflow

8 in. Circular Gravity Sewer
Pipe Out @ 12 O'Clock

Pipe Height: (in.) Direct
Pipe Material: **Clay** ☐ Pipe Lined
Invert Depth: **8.65** (ft.) Flow Characteristics: **Fast**
Deposits: ☒ None ☐ Mud ☐ Sludge ☐ Debris ☐ Grease
Silt Depth: (in.) Deposits Extent:
Infiltration: **None** Pipe Seal Cond: **Sound**

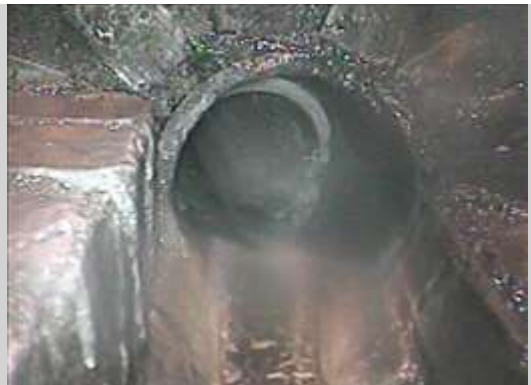
5 O'Clock Inflow

6 in. Circular Gravity Sewer
Pipe In @ 5 O'Clock

Pipe Height: (in.) Direct
Pipe Material: **Clay** ☐ Pipe Lined
Invert Depth: **7.88** (ft.) Flow Characteristics: **Fast**
Deposits: ☒ None ☐ Mud ☐ Sludge ☐ Debris ☐ Grease
Silt Depth: (in.) Deposits Extent:
Infiltration: **None** Pipe Seal Cond: **Sound**

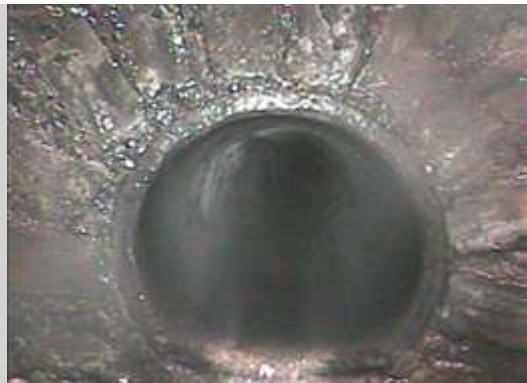
6 O'Clock Inflow

8 in. Circular Gravity Sewer

Pipe In @ 6 O'Clock

Infiltration: **None** Pipe Seal Cond: **Sound**
